Manhole Inspection Summary

Manhole # S29KK_022MH

Location Address: **850 PARK AVE**

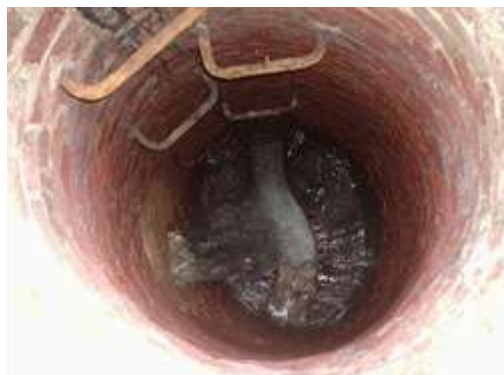
Top View

Corroded steps. Bench debris.

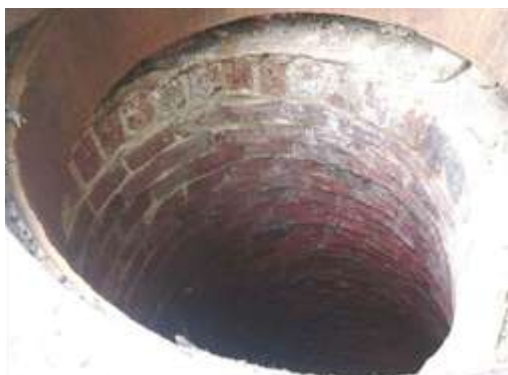
Defect

Frame leaks. Frame offset. Adjustment deterioration and infiltration. Corbel and Barrel infiltration.

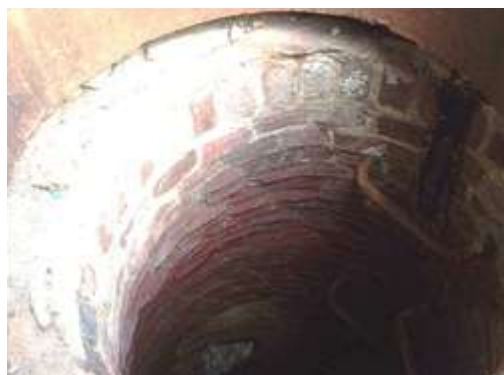
Defect

Frame leaks. Frame offset. Adjustment deterioration and infiltration. Corbel infiltration.

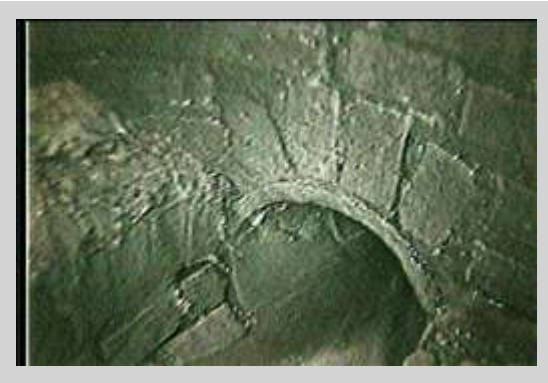
10 in. Circular Gravity Sewer Pipe Out @ 12 O'Clock

Channel deterioration.

Infiltration: **None** Pipe Seal Cond: **Cracked**

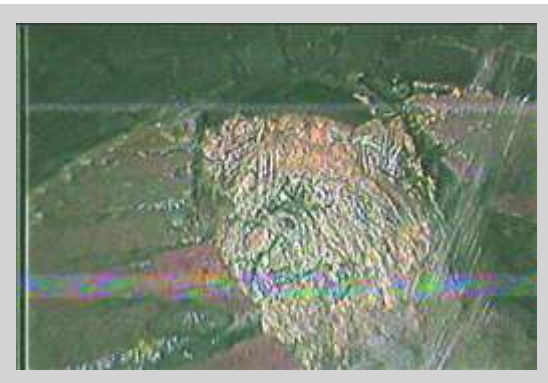
10 in. Circular Gravity Sewer Pipe In @ 6 O'Clock

Bench deterioration.

Deposits: ☐ None ☐ **Mud** ☐ Sludge ☒ **Debris** ☒ **Grease**

Silt Depth: **8** (in.) Deposits Extent: **Heavy**

Infiltration: **Evidence** Pipe Seal Cond: **Broken**

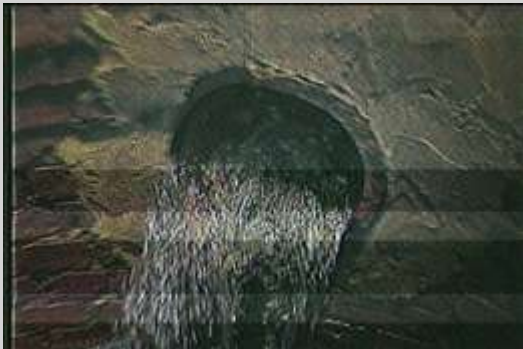
10 in. Circular Gravity Sewer
Pipe In @ 9 O'Clock

Deposits: ☐ None ☒ **Mud** ☐ Sludge ☒ **Debris** ☐ Grease

Silt Depth: **5** (in.) Deposits Extent: **Medium**

Infiltration: **Evidence** Pipe Seal Cond: **Unknown**
